# AVONBANK MINERAL SANDS PROJECT

MINE REHABILITATION

Factsheet

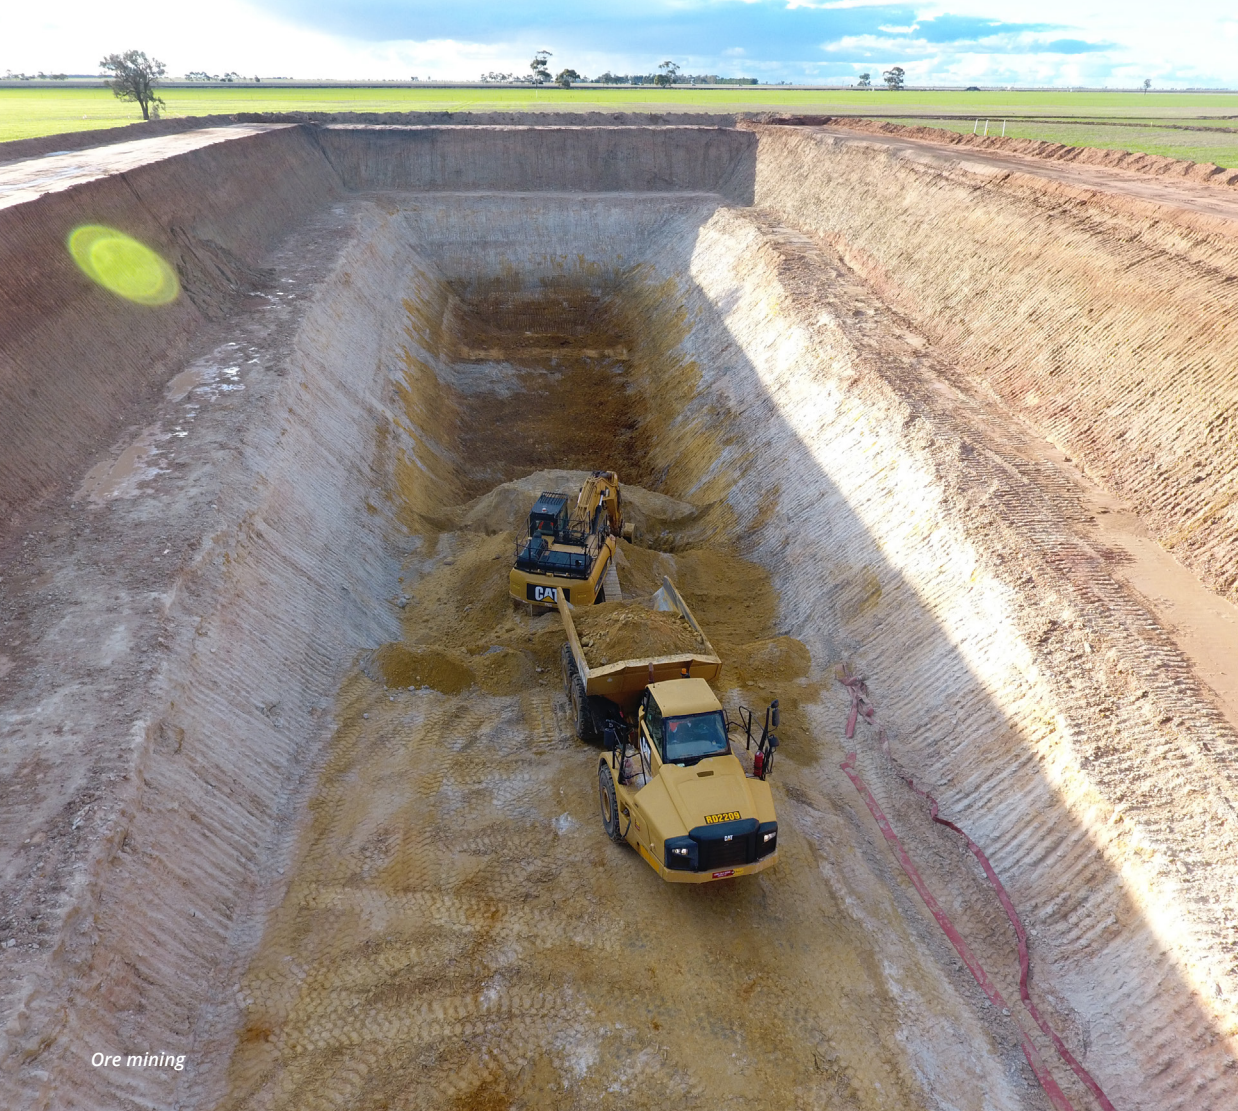
Ore mining

Following removal and stockpiling of the soils and overburden, ore was excavated and trucked to the pilot plant for processing.

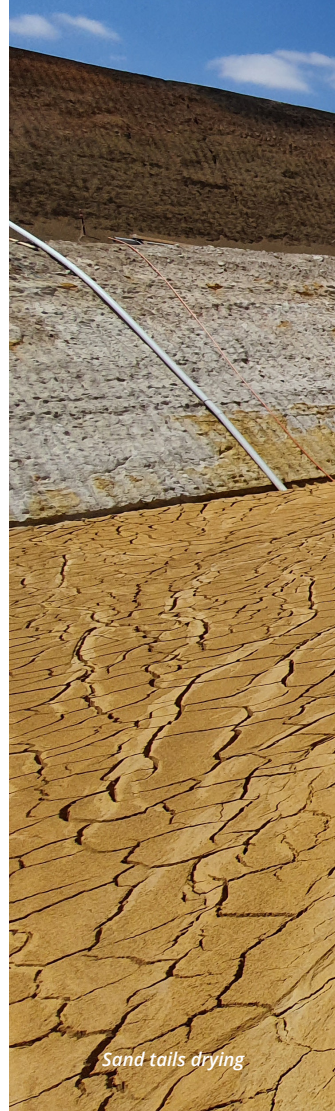
Sand tails drying

In-pit tails were left to consolidate for around 9 months. Geotechnical testing was undertaken

to demonstrate that the tails had consolidated sufficiently. Following tails consolidation, overburden was placed followed by placement of the subsoils and topsoil.

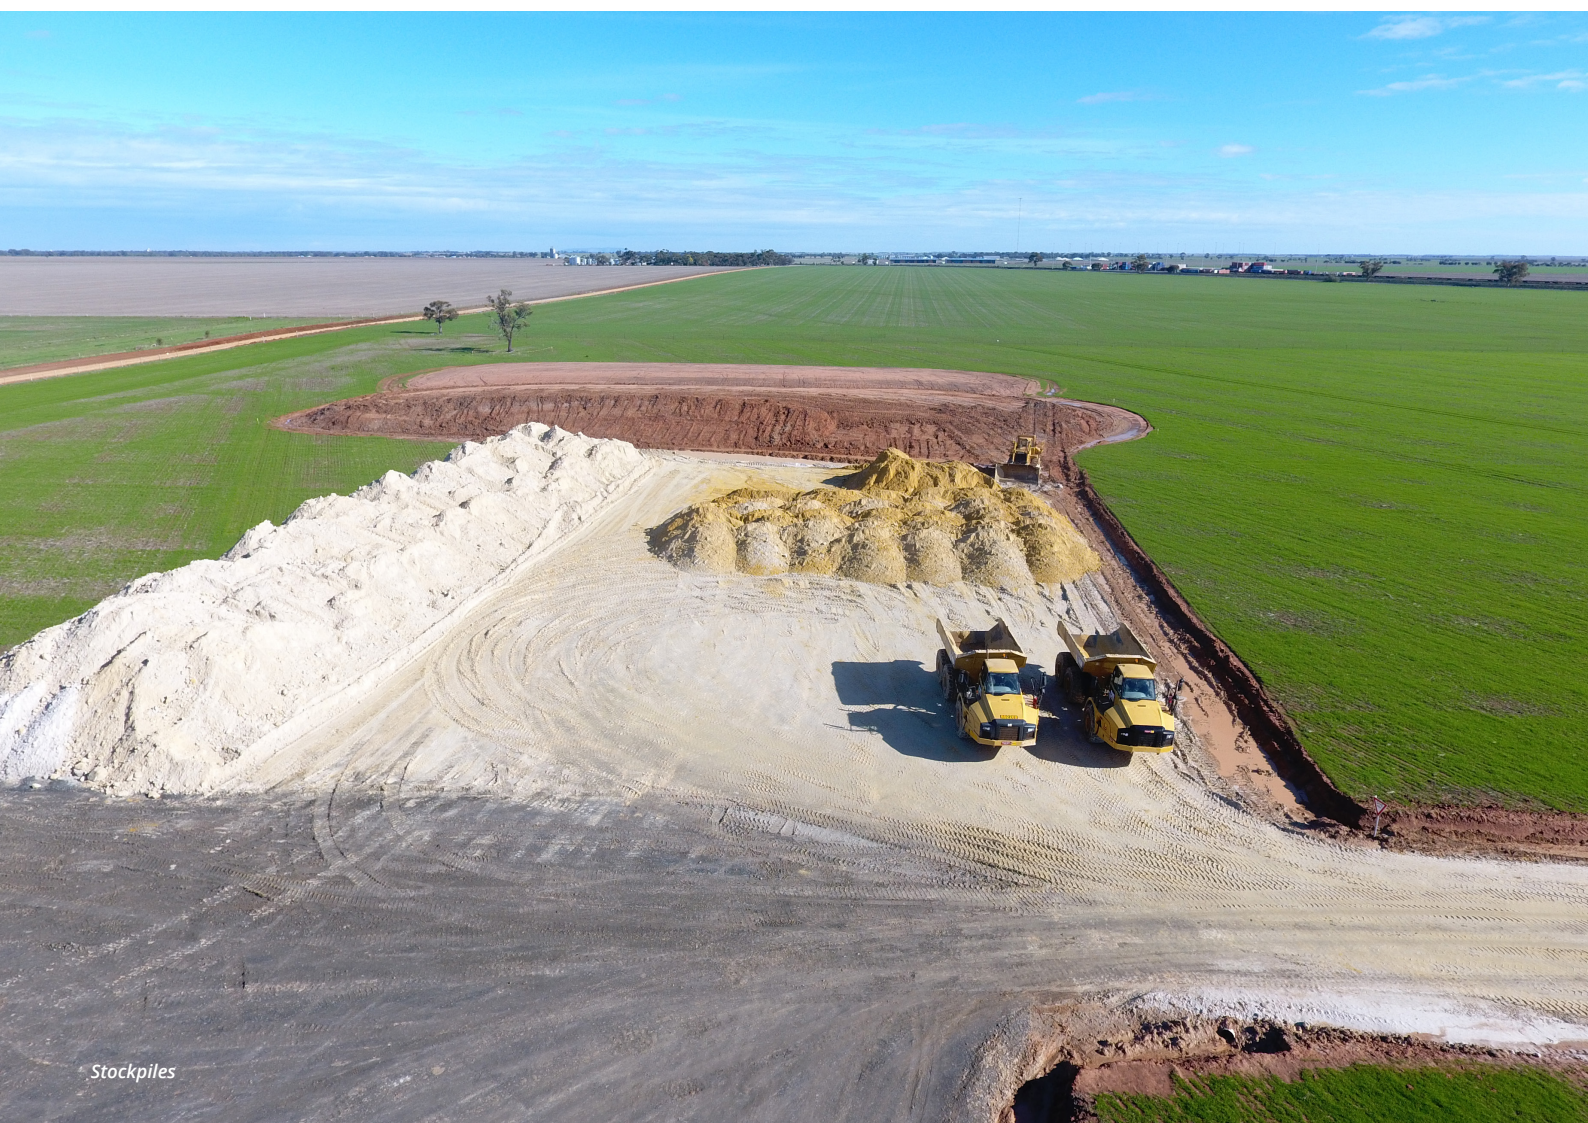
Stockpiles

Following the soil surveys, topsoil and subsoils were stripped and three separate stockpiles were established for topsoil, upper and lower subsoil units and a fourth stockpile was established for excavated overburden.

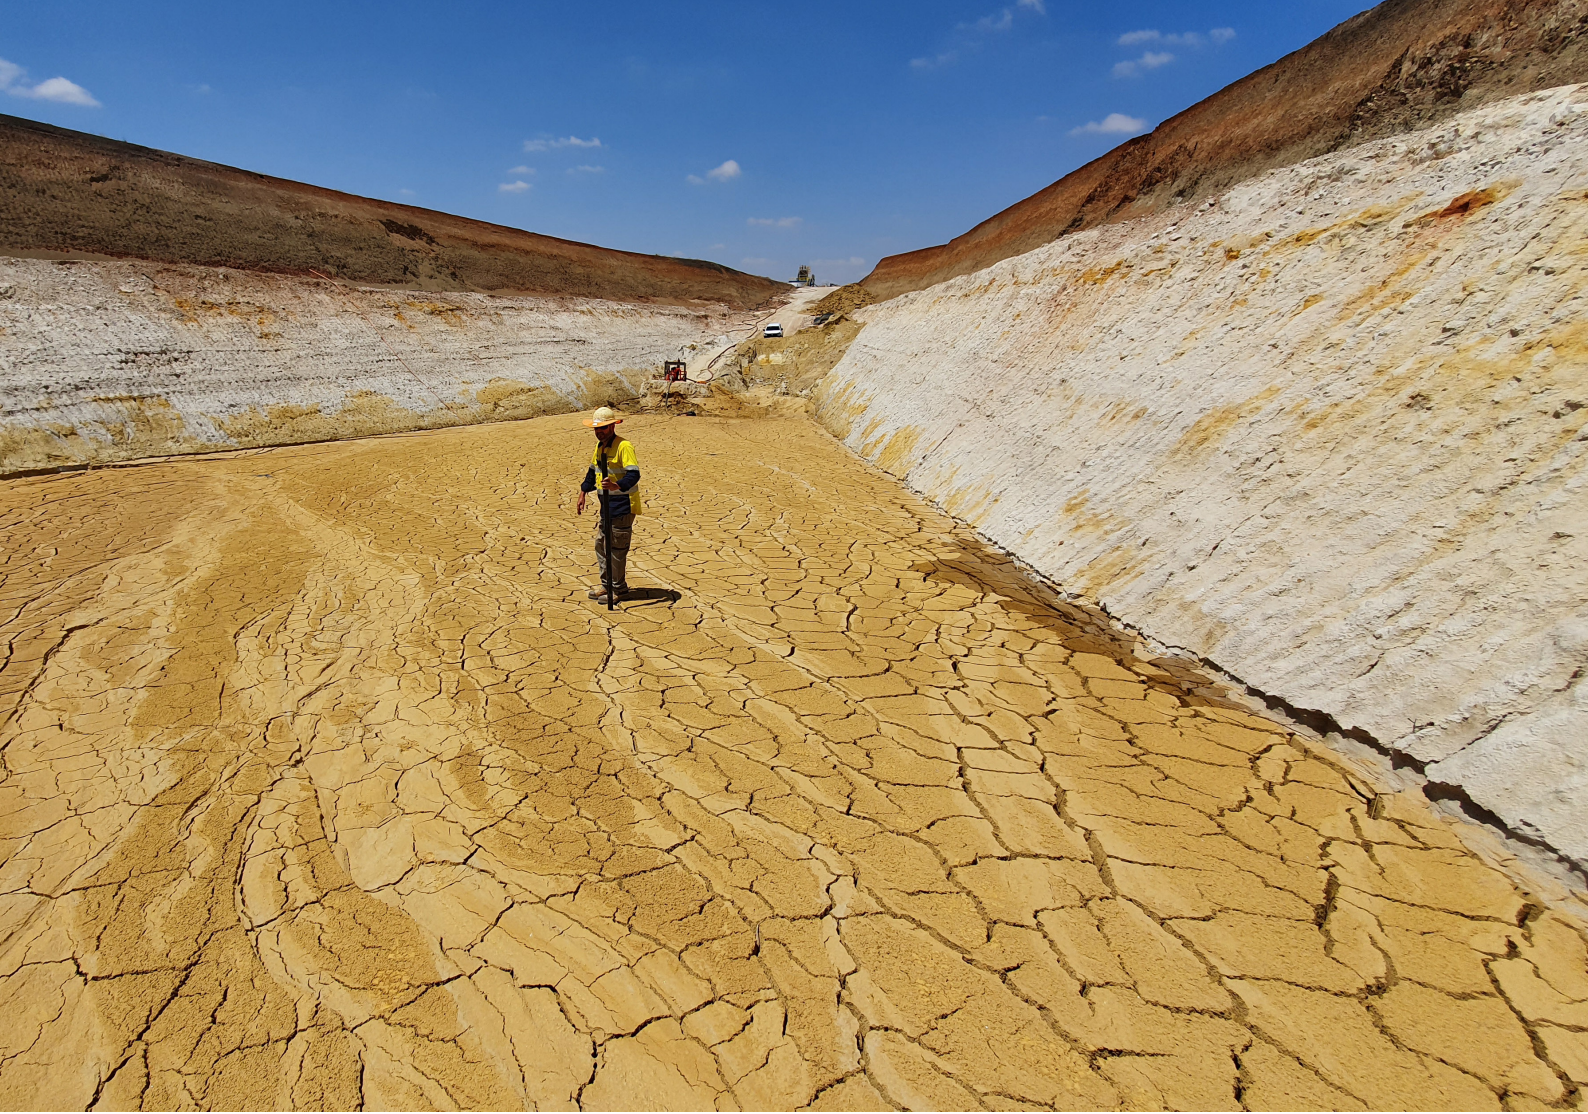
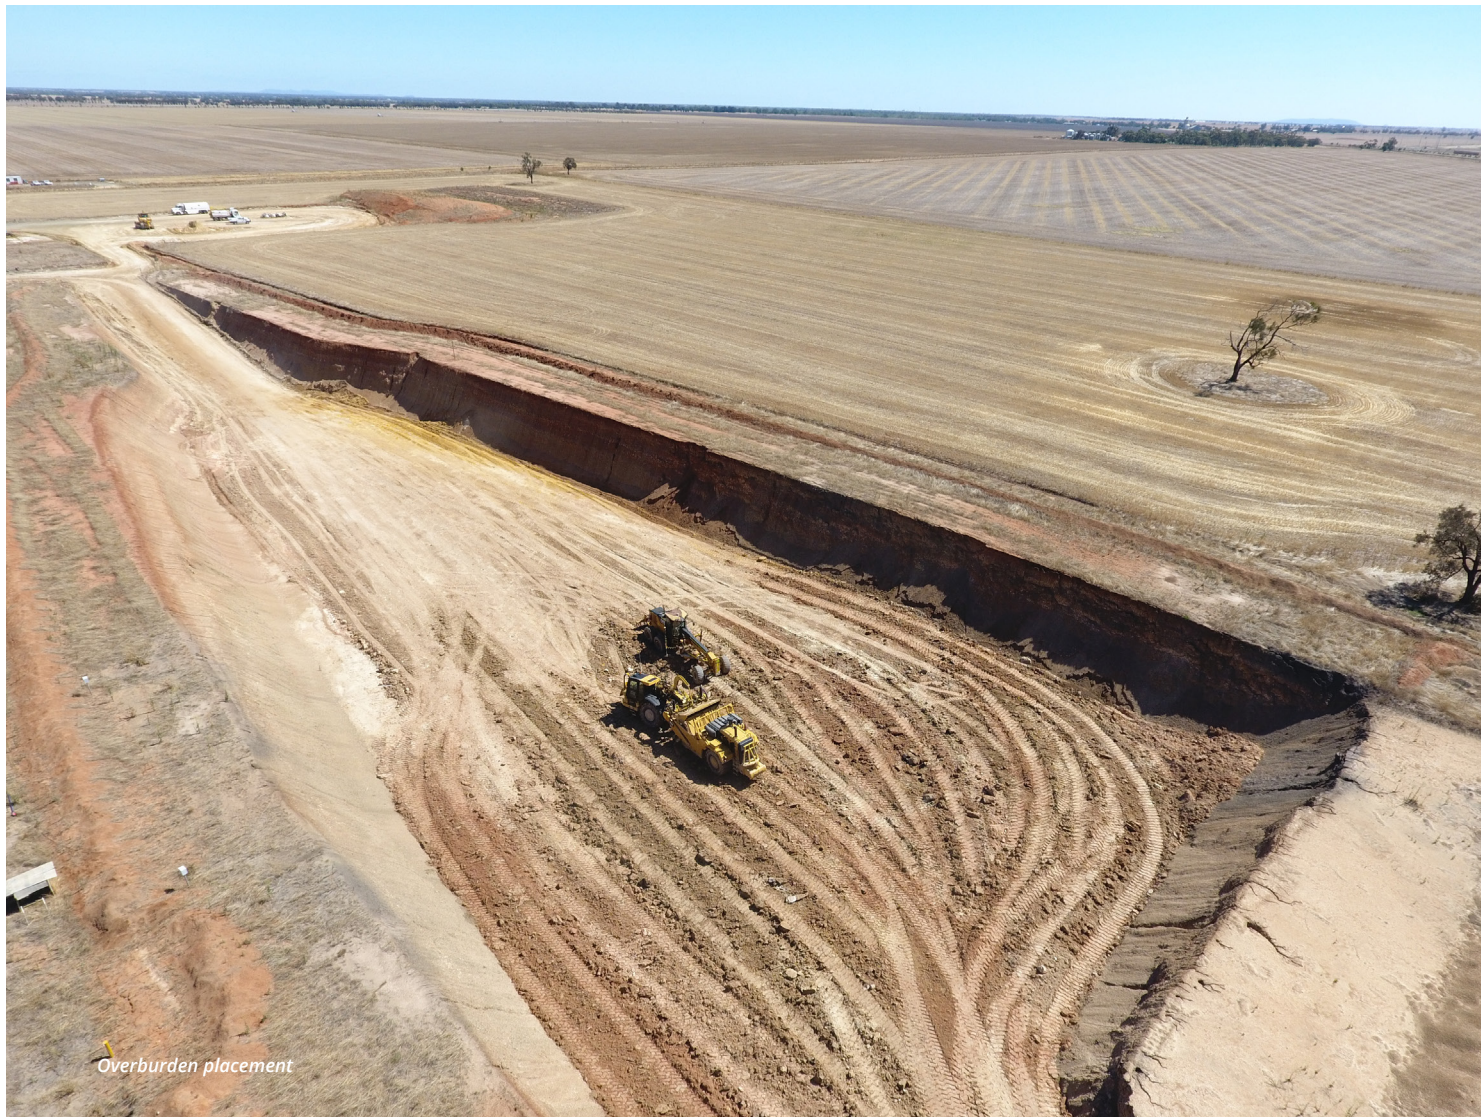
Overburden placement

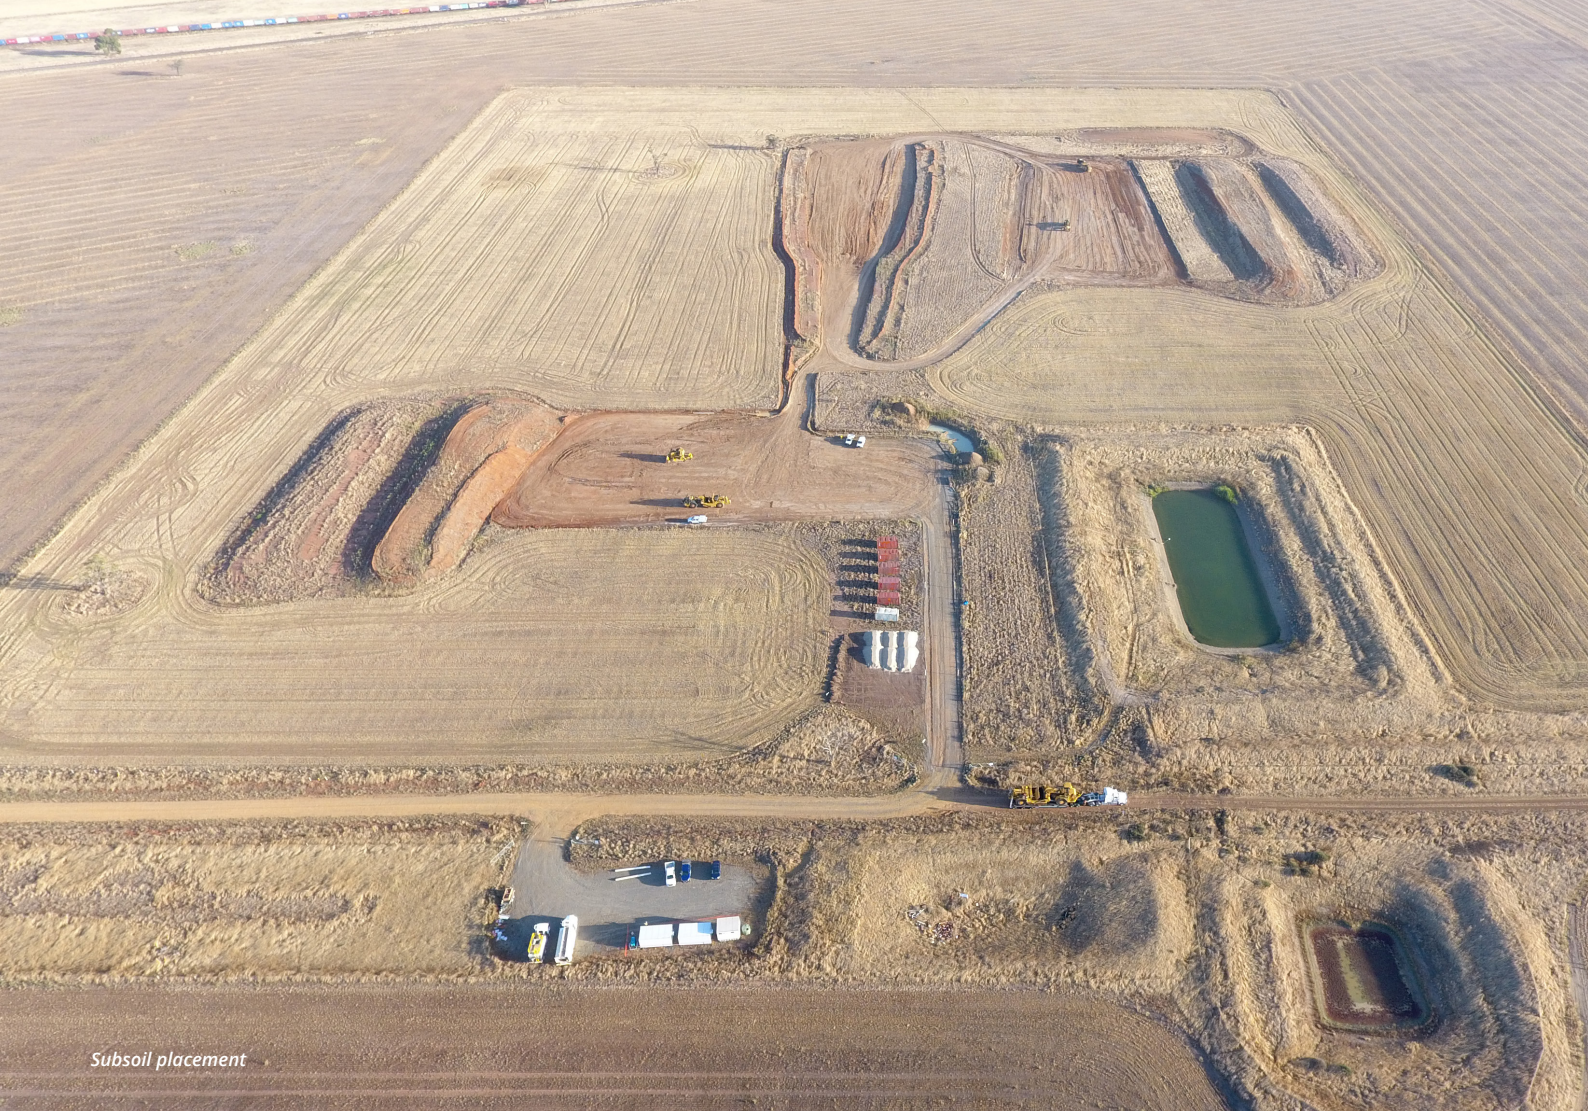
*Subsoil placement*

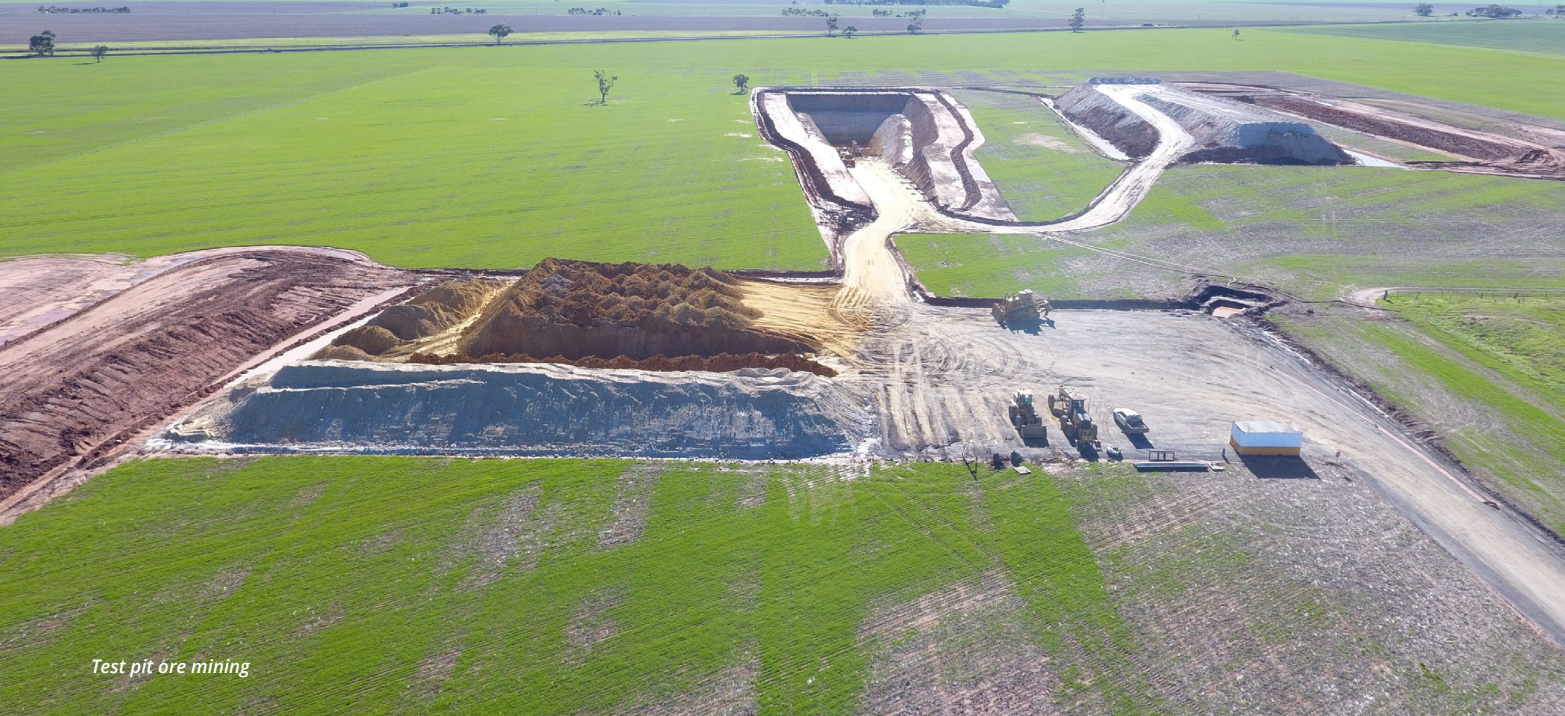
*Test pit ore mining*

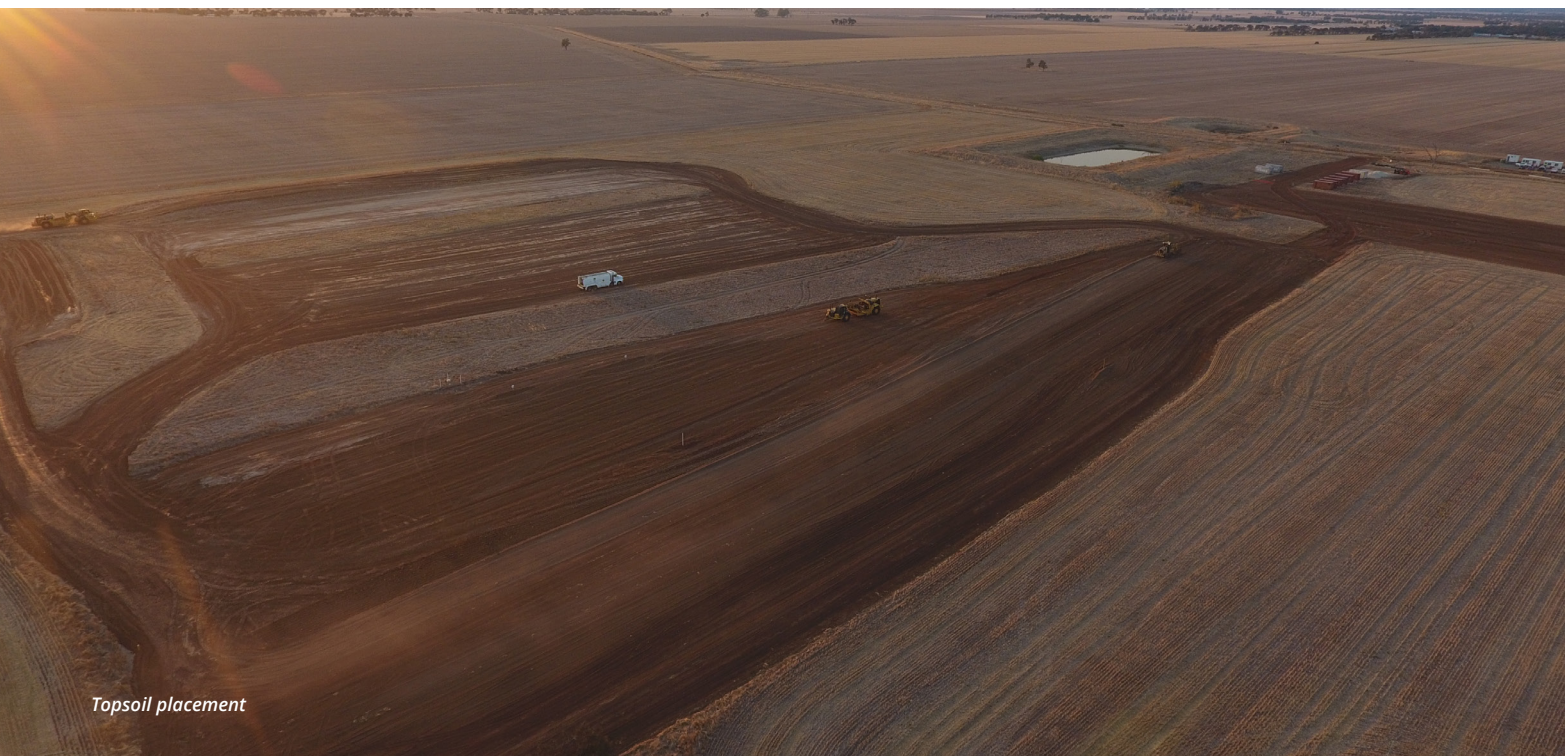
*Topsoil placement*

Following topsoil placement, the area was seeded with barley in 2021, lentils in 2022 and wheat in 2023.

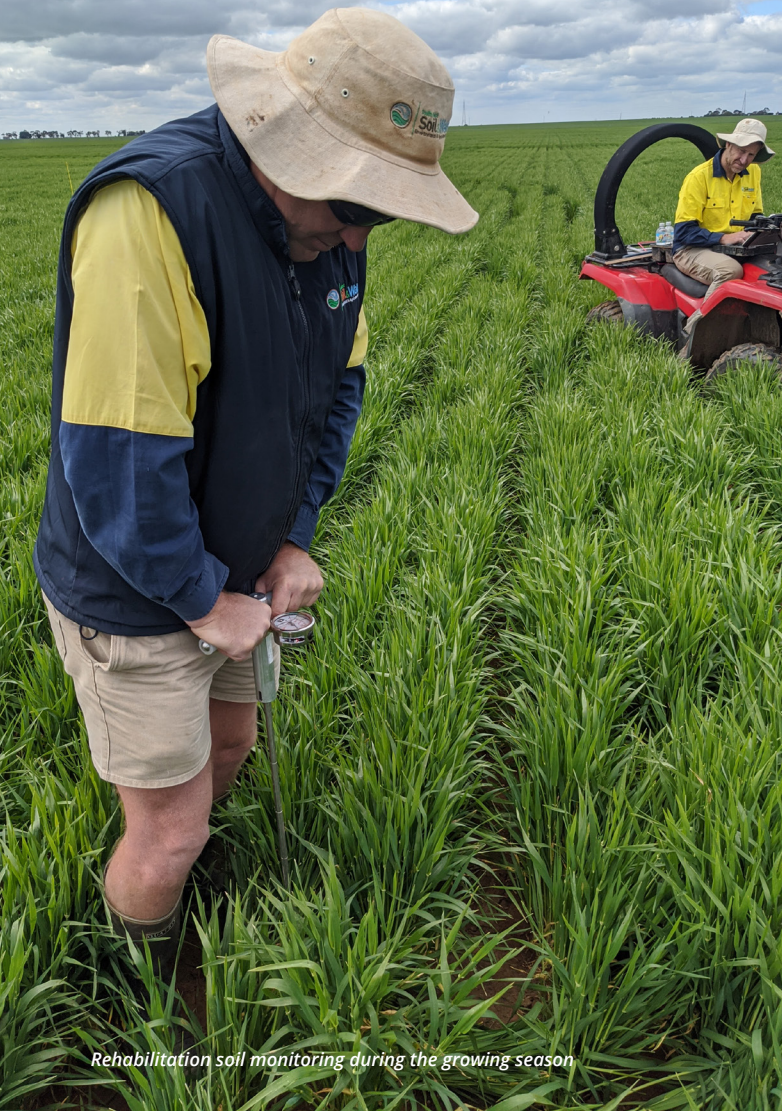
*Rehabilitation soil monitoring during the growing season*

Rehabilitation monitoring was conducted during each growing season.

The site showed no material evidence of ground movement or erosion, and the estimated crop yield monitored through each growing season were similar or higher in the rehabilitated site than the unmined areas in 2021 and 2022.
